Blue Springs Lake

Operation and Maintenance Manual

Construction Foundation Report

Volume One

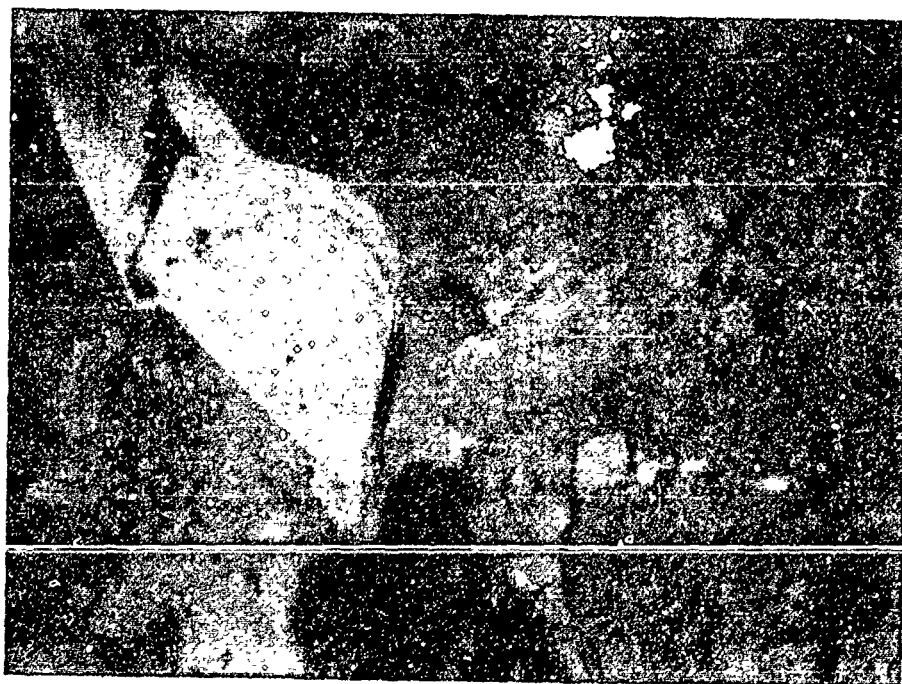
66. Blue Springs Lake, 26 November 1984, Neg. No. 396.
Backhoe removing rock along right abutment, east
of conduit, which separated as a result of stress
release. Loosened zone ran from station 48+65 to
station 49+09 center line of conduit.

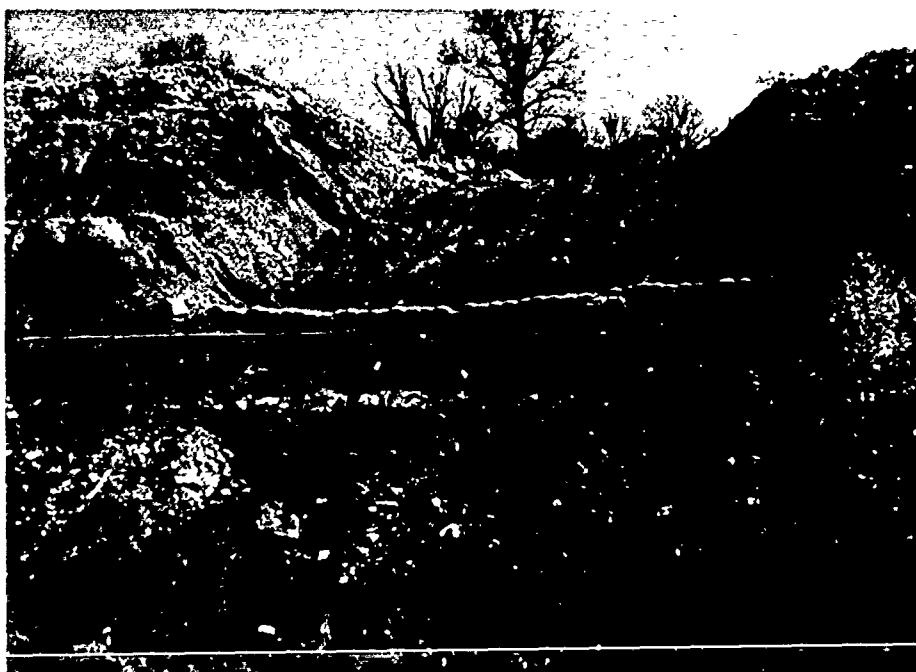
| <u>PHOTO NO.</u> | <u>SUBJECT</u> | <u>NEGATIVE NO.</u> |
|---|--|---|
| 68 | 16 April 85, sandbag reventment on right abutment. Ponded water was diverted downstream through irrigation pipe. Note deep incising in cover materials down to foundation rock from runoff, Station 75+30. | #407 |

68. Blue Springs Lake, 16 April 1985, Neg. No. 407.
Sandbag revetment on right abutment. Ponded water
was diverted downstream through an irrigation pipe.
Note deep incising in cover materials down into
foundation rock. From station 75+30 looking east.

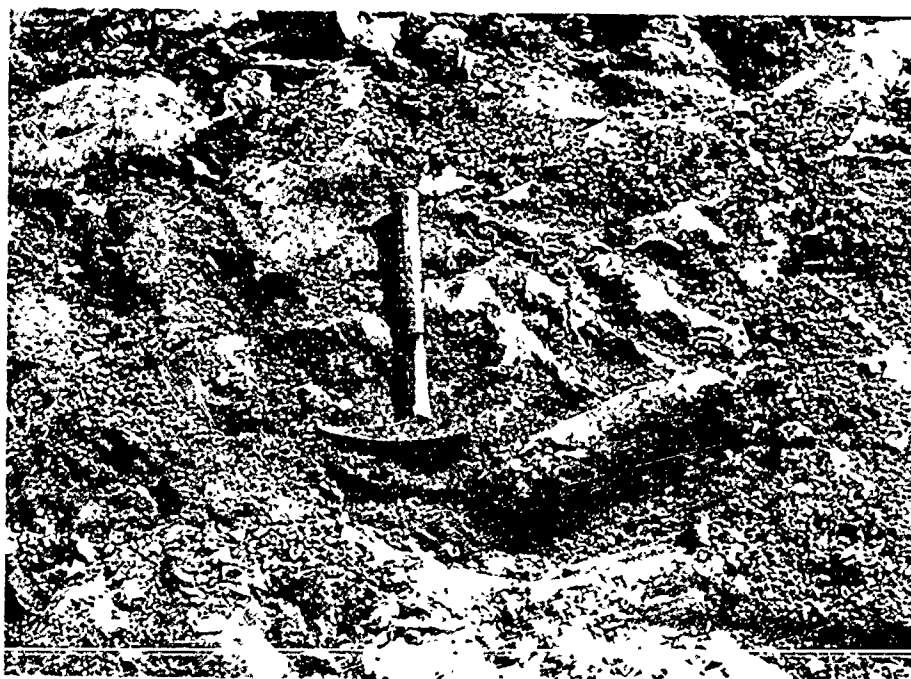
130. Blue Springs Lake, 21 August 1986, Neg. No. 683.
Right abutment, cutoff trench. Detail of maroon
clay in stratigraphic sequence of Critzer Limestone.
Highly slickensided. Station 73+85 and El. 810.
